Metro Aviation, Inc.

EC 135
SERVICE BULLETIN
SB 135M-150-001

SPIFR GPS Navigation System – Modification of

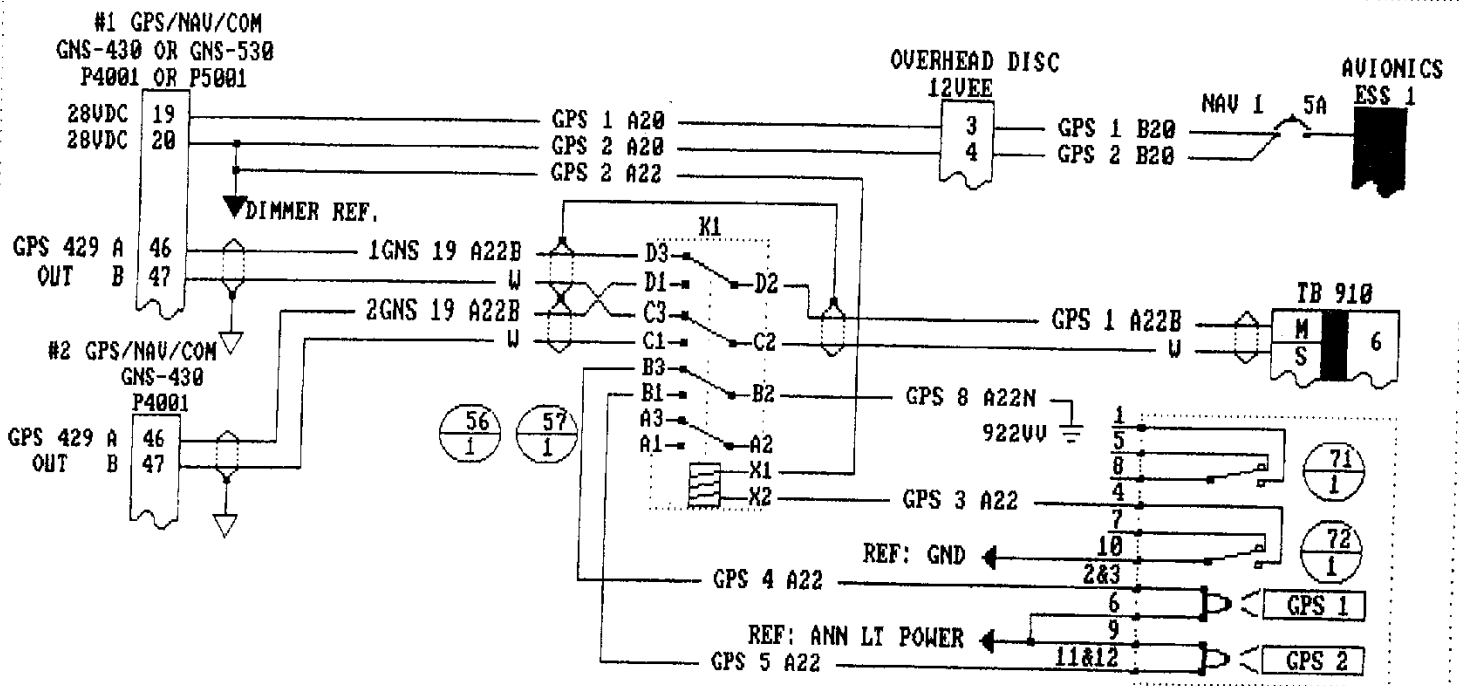
EXISTING SYSTEM

REASON: IT HAS BEEN FOUND THAT IF A LOSS OF POWER TO THE K1 GPS DATA RELAY AND THE #1 GPS/NAV/COM SYSTEM THERE WOULD BE A LOSS OF GPS DISPLAYED INFORMATION ON THE PILOT NAVIGATION DISPLAY (SMD-45 ND). FULL GPS AND VLOC NAVIGATION IS STILL AVAILABLE ON THE REMAINING #2 GPS/NAV/COM SYSTEM WITH VLOC INFORMATION STILL PRESENTED ON THE PILOT ND. THIS IS A MODIFICATION TO ELIMINATE THIS ISSUE.
