EC 135

SERVICE LETTER

Product-Vapor Cycle Air conditioning Installations

**Applicability- All EC135P1, P2, P2+, T1, T2, T2+ aircraft
with kit installed**

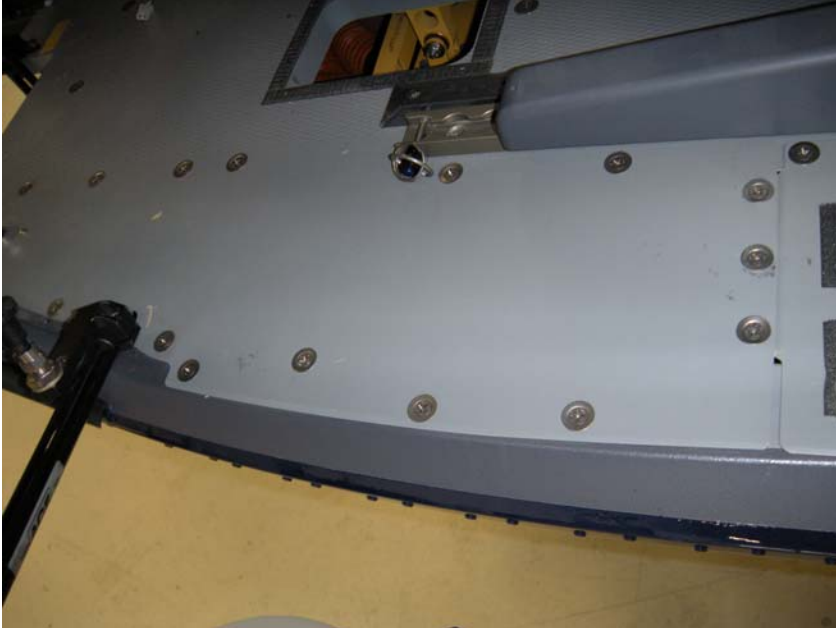
Picture 1

Picture 1- the area of the aircraft concerned

Remove the forward side shell panel (picture 1) in accordance with the ECD AMM. Perform visual inspection of the duct installation and pitot static tube routing. Installation should be similar to picture 2 AND any relevant information found in the ECD AMM relevant to the installation.

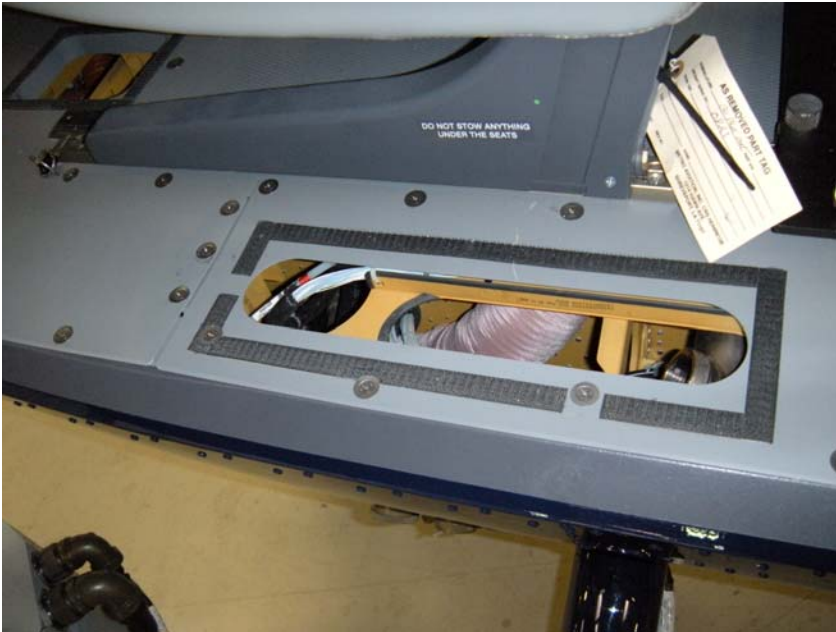
Picture 2

Picture 2- Copilot collective access hole

Remove the copilot collective if installed or the collective stick blanking cover in accordance with the proper ECD AMM instructions. With inspection flashlight or other suitable light source look through the access hole (Picture 2) and forward to the hammer. The installation shall be similar to picture 3.

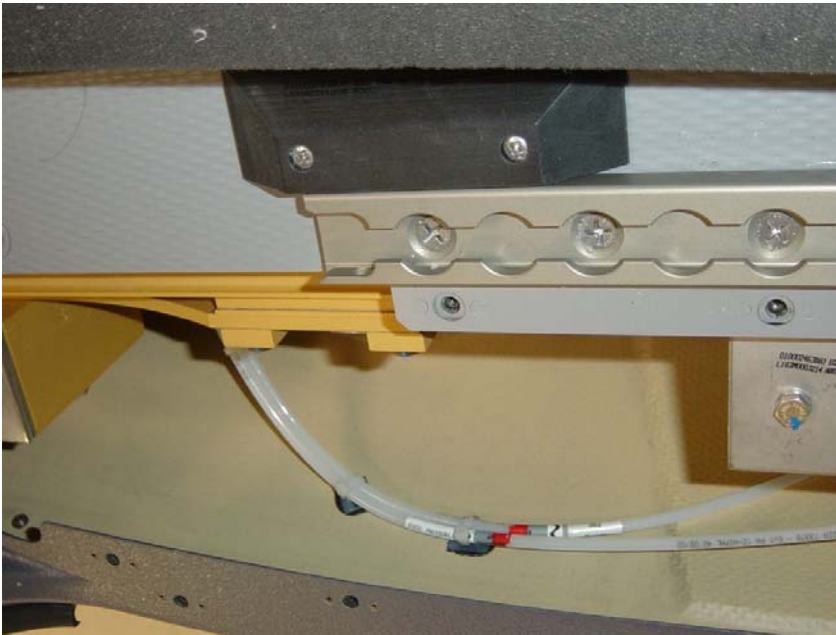
Picture 3

Picture 3- Unmodified side shell area

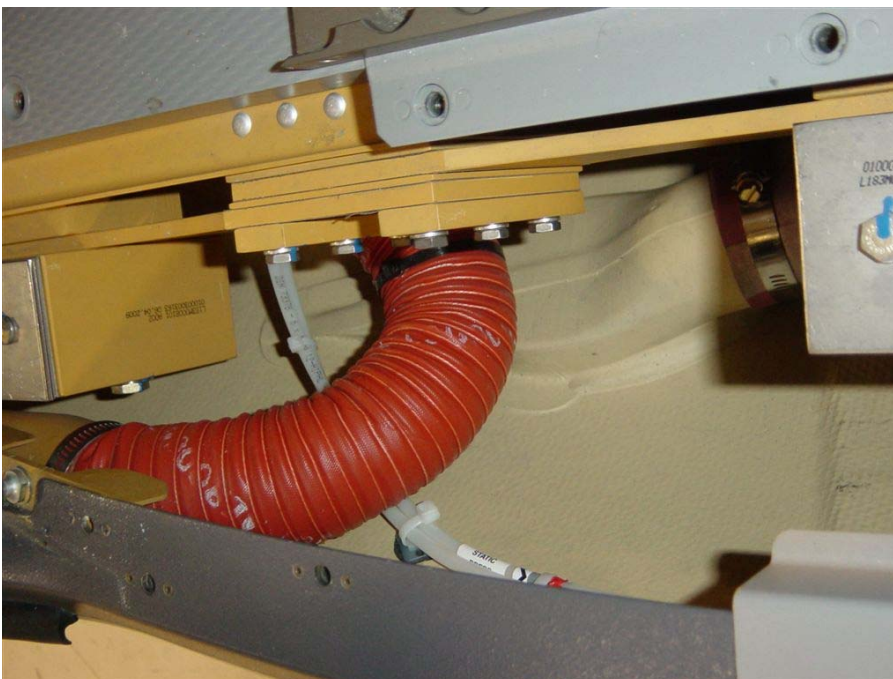
Picture 4

Picture 4- properly installed airconditioning tube

If Pitot Static tubes and airconditioner tube is not routed IAW Picture 4, route pitot static lines correctly, correct routing of lines in accordance with the picture 4 AND any information contained in the ECD AMM. Ensure that all tests are conducted as necessary by the ECD AMM required when pitot static system is opened.
